Wollongong City Council

GlasGrid Solution No. 1

GlasGrid performs well in Wollongong field trials

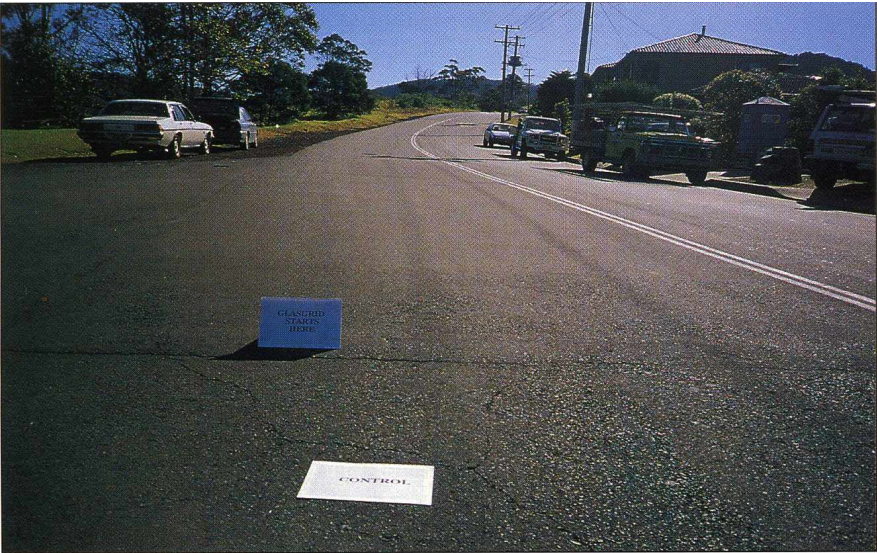
O'Briens Road, Figtree: Note the cracked control section in the foreground, with the GlasGrid reinforced area immediately behind.

The site selected for the trials was O'Briens Road, Figtree, which is a local road and a minor bus route. Constructed in 1970, this was one of the first trial pavements built using a slag roadbase.

A 450 m long section of the road was selected for the trials including the section which had been resurfaced with asphaltic concrete without any crack control procedures. Discussions were held with the suppliers of various crack control products and seven trials were proposed in addition to the Control Section already constructed.

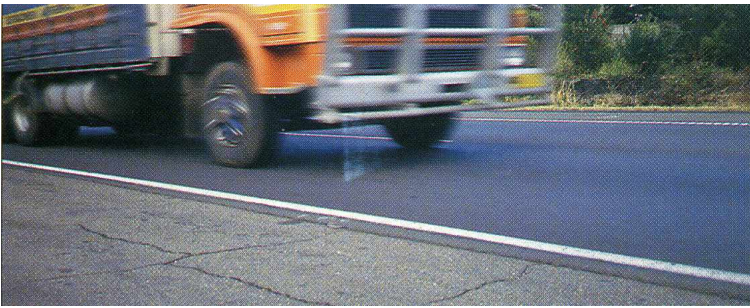
On another project in Wollongong, the F6, typical cracking can be seen on the shoulder, with no cracking visible on the travelling lanes, which were reinforced with GlasGrid prior to AC overlay.
