Crack Routing and Sealing Blacktown Council

Crack Routing & Sealing Solution No. 1

New Crack Routing and Sealing process wins seal of approval

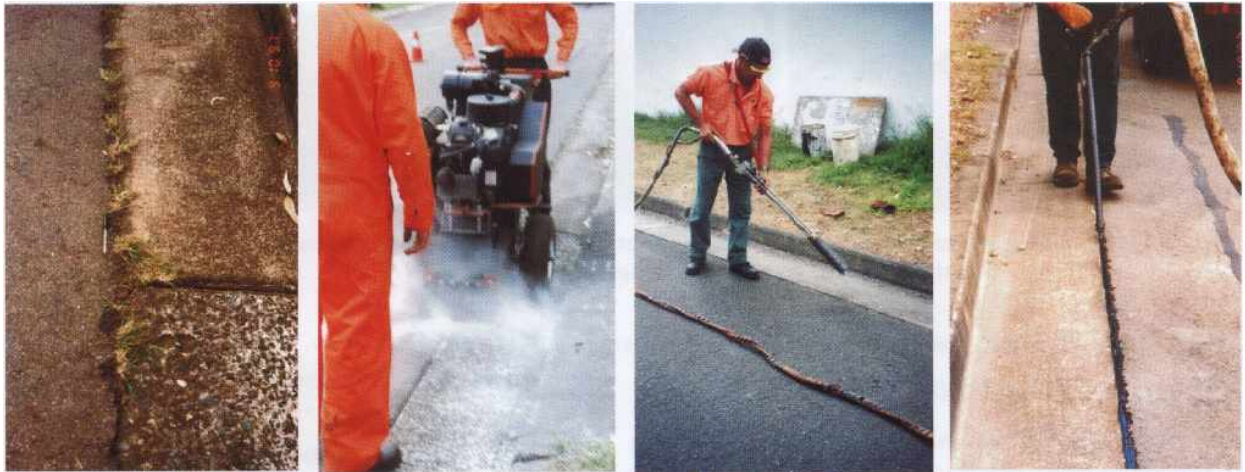
At Blacktown, a recurring grass growth between pavement and curb lip (left) is removed, then the routed crack is thoroughly cleaned then sealed.

“One problem street, Idriess Crescent, had grass growing up between the kerb lip and the

asphalt. It became a

constant maintenance headache. We tried everything from spraying it, to chipping it out manually –going back year after year to try to address the problem. Finally we used SAMI’s Crack Routing and Sealing process and we haven’t had a problem since”.

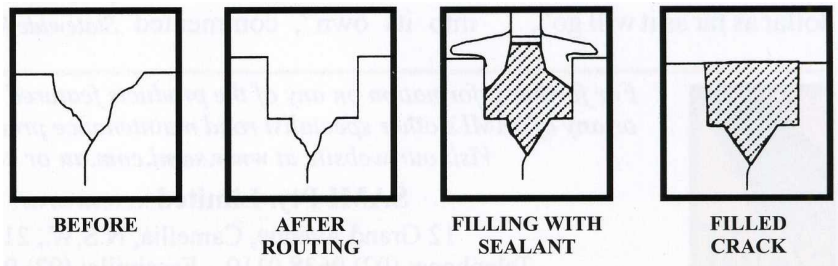
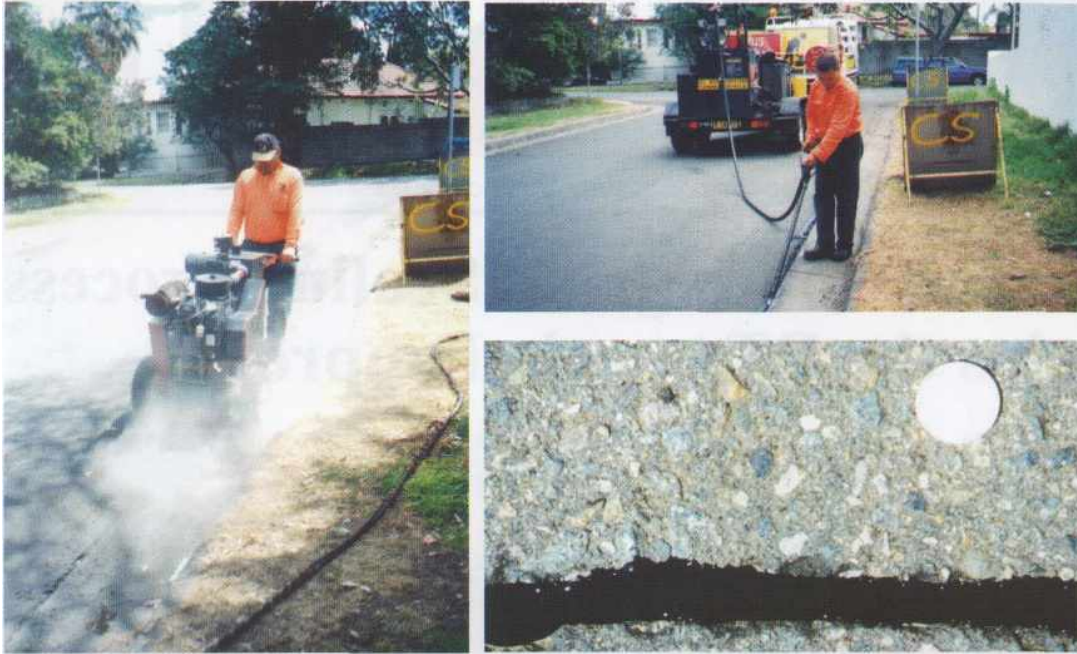
"SAMI's routing process provides a cleaner job that can be filled properly and ensures that the sealant gets down to where it is needed".

“With the routing, you’ve definitely got a clean job

that can be filled properly and you ensure that the sealant gets down to where it is needed, especially where the crack varies in width. When it starts getting smaller you are really only banding over the top, said Mr Shorten. “SAMI’s Crack Routing and Sealing process definitely is the ‘Rolls Royce’ method and you get ‘Rolls Royce’ results!”
